## End of Trimester Summary

May - August 2008

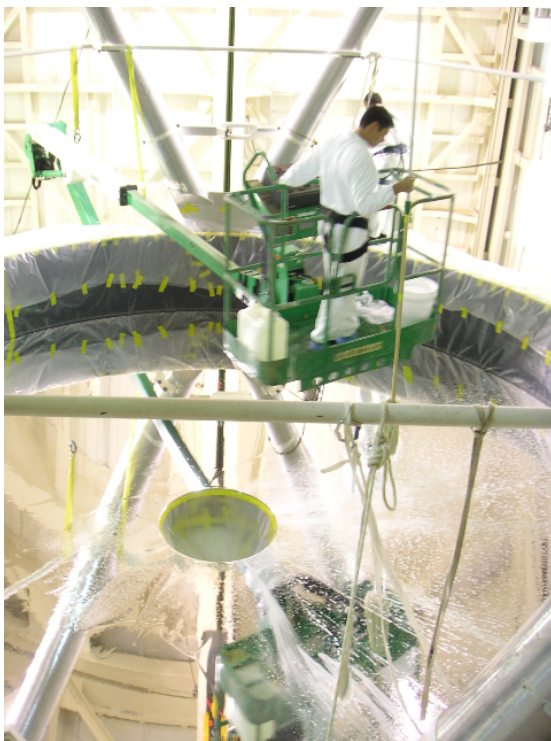
R. Ortiz maneuvers over the primary mirror while “dabbing” the surface with a soapsuds-filled large cotton swab.

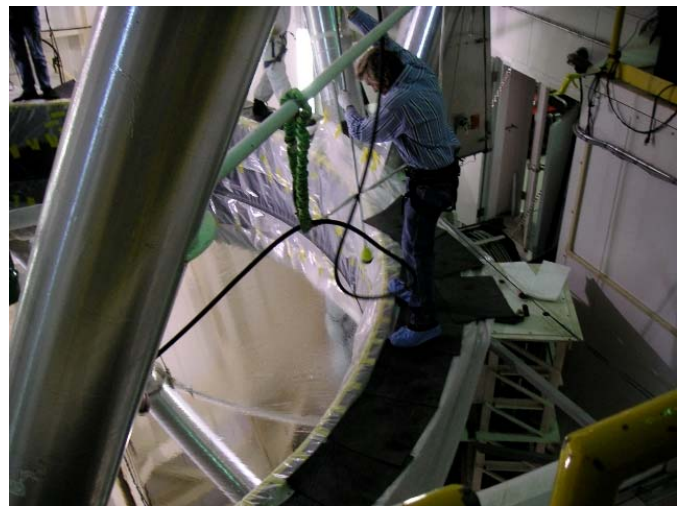
The mirror edge is “blown-dry” with filtered high pressure air.

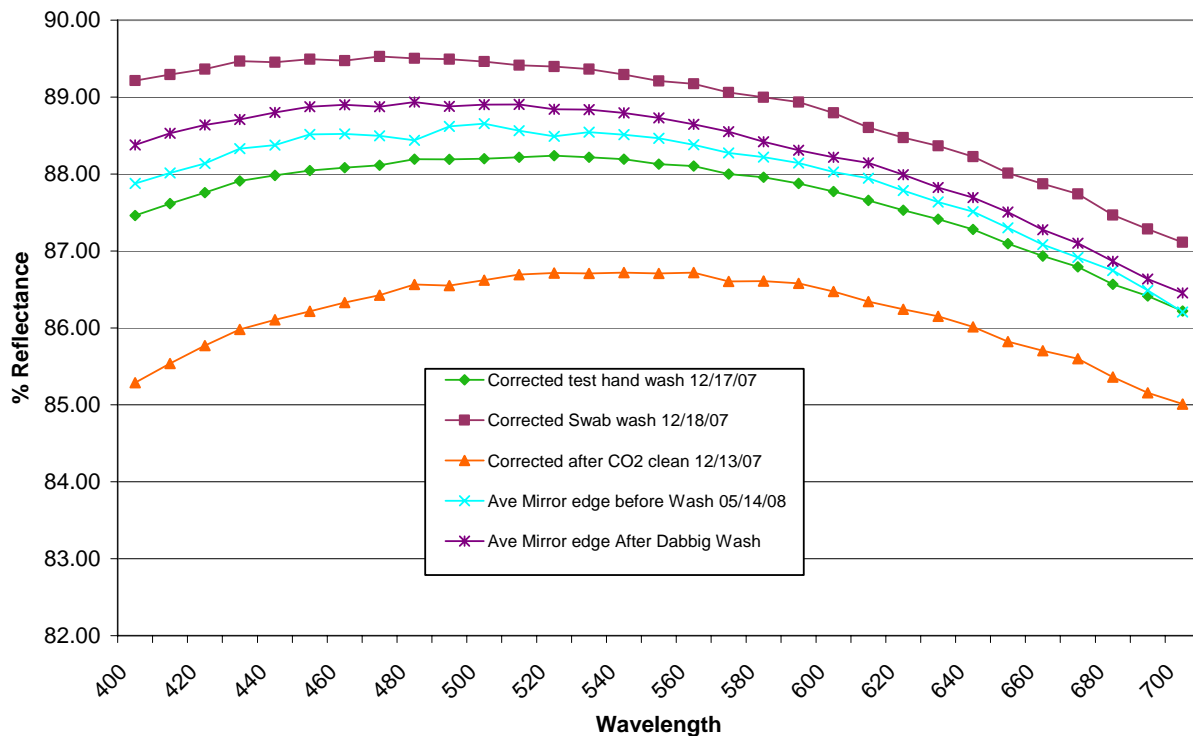
Reflectance CO2 Clean vs Hand Wash vs Swab Wash Dec07 & May08

The plots below show the reflectance and scattering measurements before and after the wash. For comparison, results from December 07 are plotted as well. The results indicate that the coating is still performing extremely well.

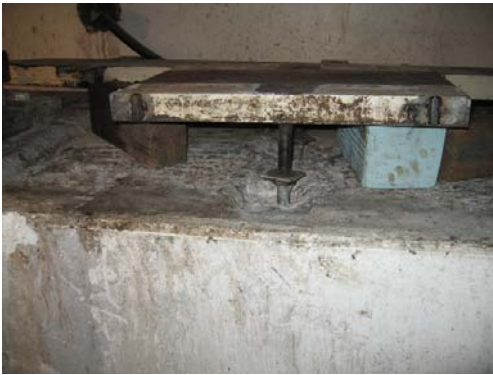
Two sections of the building track were regouted, and one section was shimmed. We also checked for levelness and verified that only three sections needed repairs at this time. The cow catchers were cleaned and aligned to the track. After regrouting, the track was cleaned and dry lube applied. The pit was also cleaned and organized.

Old grout has been removed and the track reset.

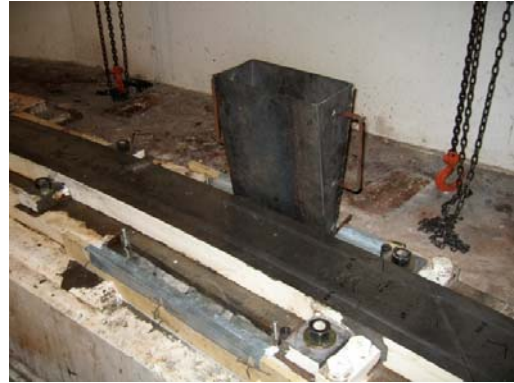
The track section alignment is verified, forms are readied for extruding cementous grout under the track and sole plates.

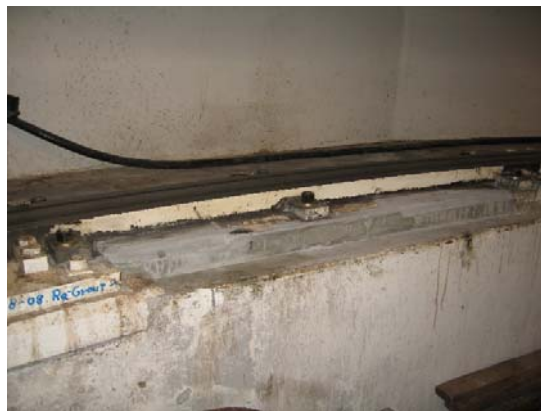
Grout is successfully placed; curing cycle is underway.
